White paper: Coated Vandersanden bricks

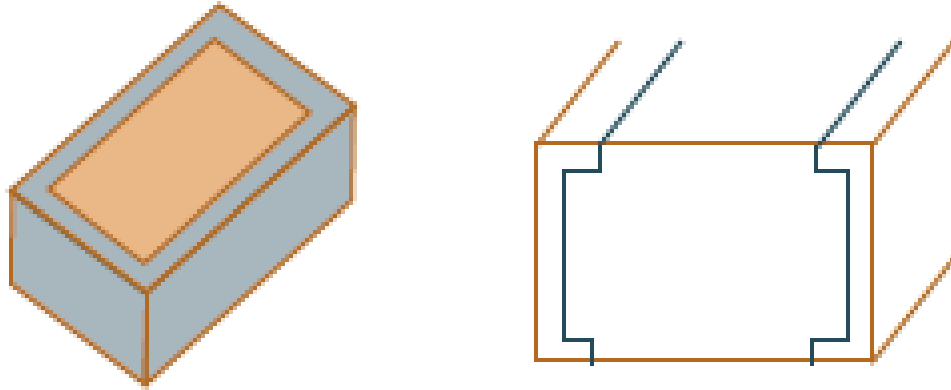
In an automated process, the stretcher and header faces of the brick are coated with a water-repellent layer. This coating penetrates approximately 5-10 mm into the brick. The bed faces (top and bottom) are not coated, so that the bricks can still be laid traditionally on a bed of mortar. However, the coating is taken 10-20 mm around the brick, onto the bed faces.

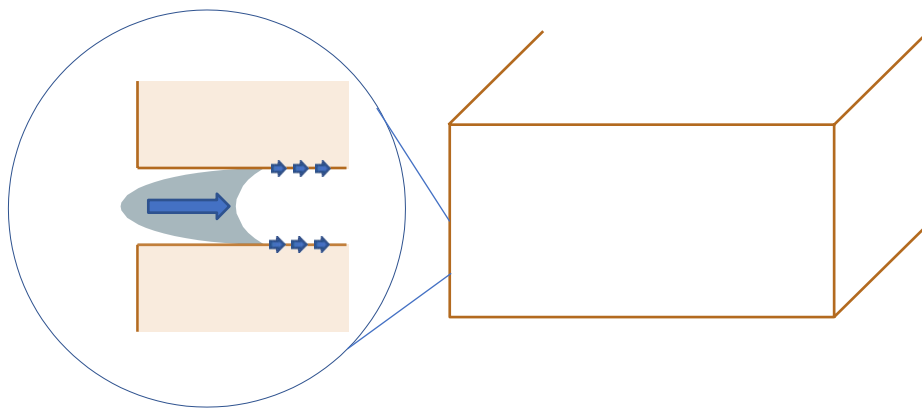
A highly absorbent brick is a product with a lot of pores, both large and small. The body of a brick acts rather like a sponge. Water is drawn by capillary action into the pores within the body of the brick.

The large pore structure of these bricks ensures that they can never freeze and break into pieces, even when they are saturated with water, as there is always sufficient space for the water to expand when it turns into ice.

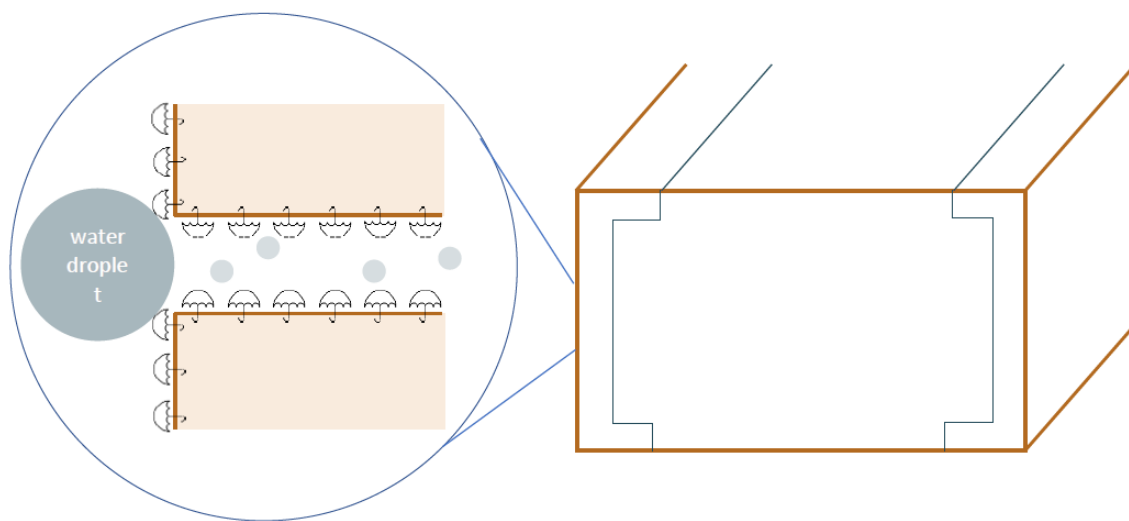
A coated brick has exactly the same pore structure as an uncoated brick. The number of pores and their size remain the same. However, the 5-10 mm coated layer will not absorb any water, the pores are covered with the water repellent coating and water droplets cannot be absorbed.

Moisture in the uncoated part of the brick can leave the brick through the uncoated bed faces or as water vapour through the coated stretcher and header faces of the brick. After all, water vapour droplets are smaller than water droplets and able to migrate through coated pores.

As the pores remain open, the bricks retain their resistance to frost.

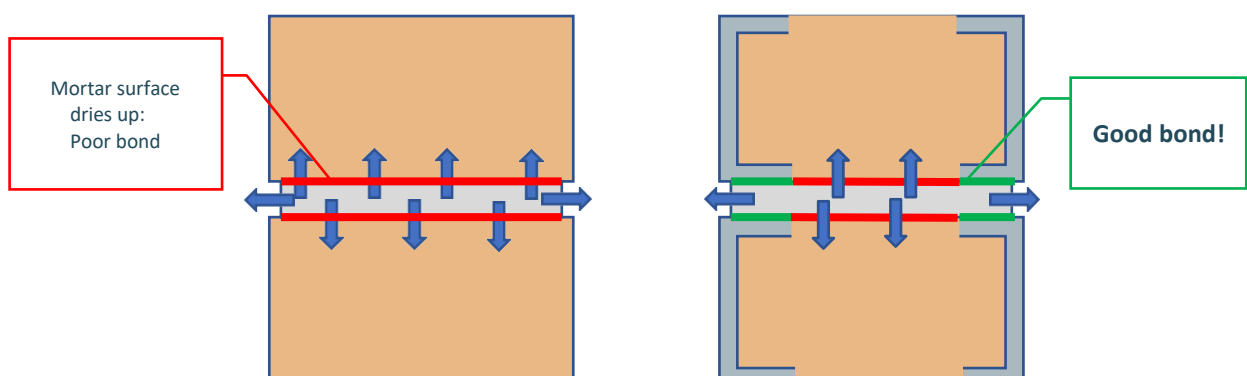
The mortar on the coated part of the bed faces cannot dry up. Tests indicate that the bond on this surface is much stronger. So the Vandersanden coated bricks combine the two features referred to above: The core absorbs, so that the brick does not shift during bricklaying and the coated edges provide additional bond.

This also applies to the pointing. All of the mortar is between the coated part of the bed faces and will not lose moisture to the brick. This increases the quality of the joint and does not have any negative effect on the bond.
